International Traffic and Road Security Congress and Fair
May 8-12, 2002 Ankara/Turkey

THE SNOW DRIFT PROBLEM AND ITS EFFECTS ON ROAD SAFETY IN TURKEY

Ibrahim Gürer, Adem Bek

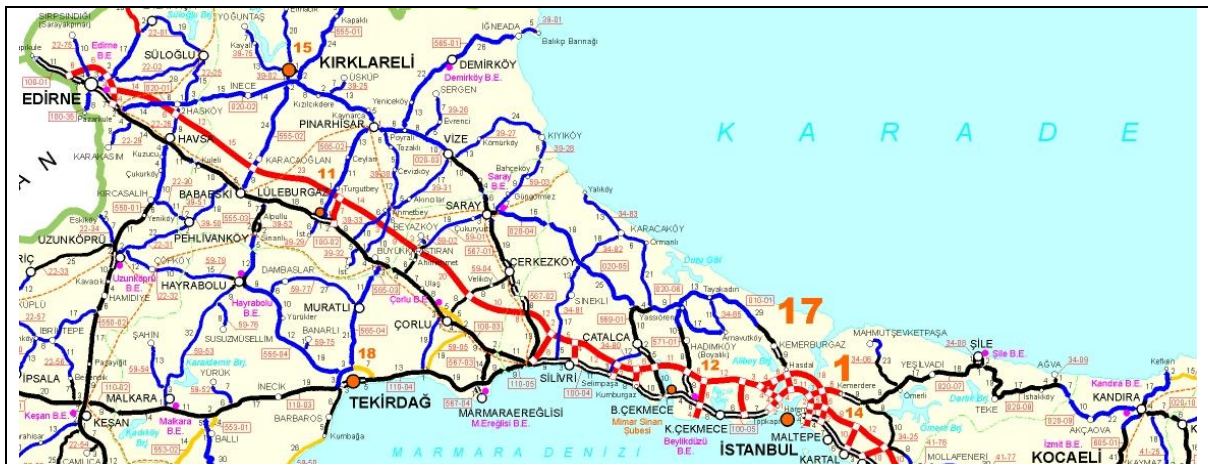
Figure 3.The map of the roads of heavy snow drift problem was faced during December 2001.

The extraordinary the snow drift problem faced along the Istanbul- Edirne Motorway, Tekirdağ- İpsala, Uzunköprü- Meriç State roads (Fig. 3) were examined by various field studies. In the state roads, the mainsnow drift problem was due to the wind that comes from the direction of the Black sea , the north. A detailed field survey and frequency analysis of snow depth in the region is needed to decide the height of the snow fence needed for different sections of the roads in the region. From the existing snow conditions it may be thought that a 3 mt. High and 220 mt. long of snow fences is to be built on the cut near Şarköy. The prevailing wind direction at Tepeüstü-Beğendik seperetion of Malkara-İpsala State Road is North. The height of drifted snow was 3 mt. and it was piled up by the wind when the site was visited. Also 6 mt. high snow piles was seen on the Istanbul- Edirne Motorway ; TEM highway at the place of the old pay-desks. It was observed that after the cut of long trees at the west junction of TEM higway, more severe snow-drift problem faced at Saray junction (Bek and Gurer 2002).
